GREAT NEAPOLITAN EARTHQUAKE OF 1857.

OBSERVATIONAL SEISMOLOGY

TO INVESTIGATE THE CIRCUMSTANCES OF THE GREAT
EARTHQUAKE OF DECEMBER 1857.

ROBERT MALLET, C.E., F.R.S., F.G.S., M.R.I.A.,
&c., &c.

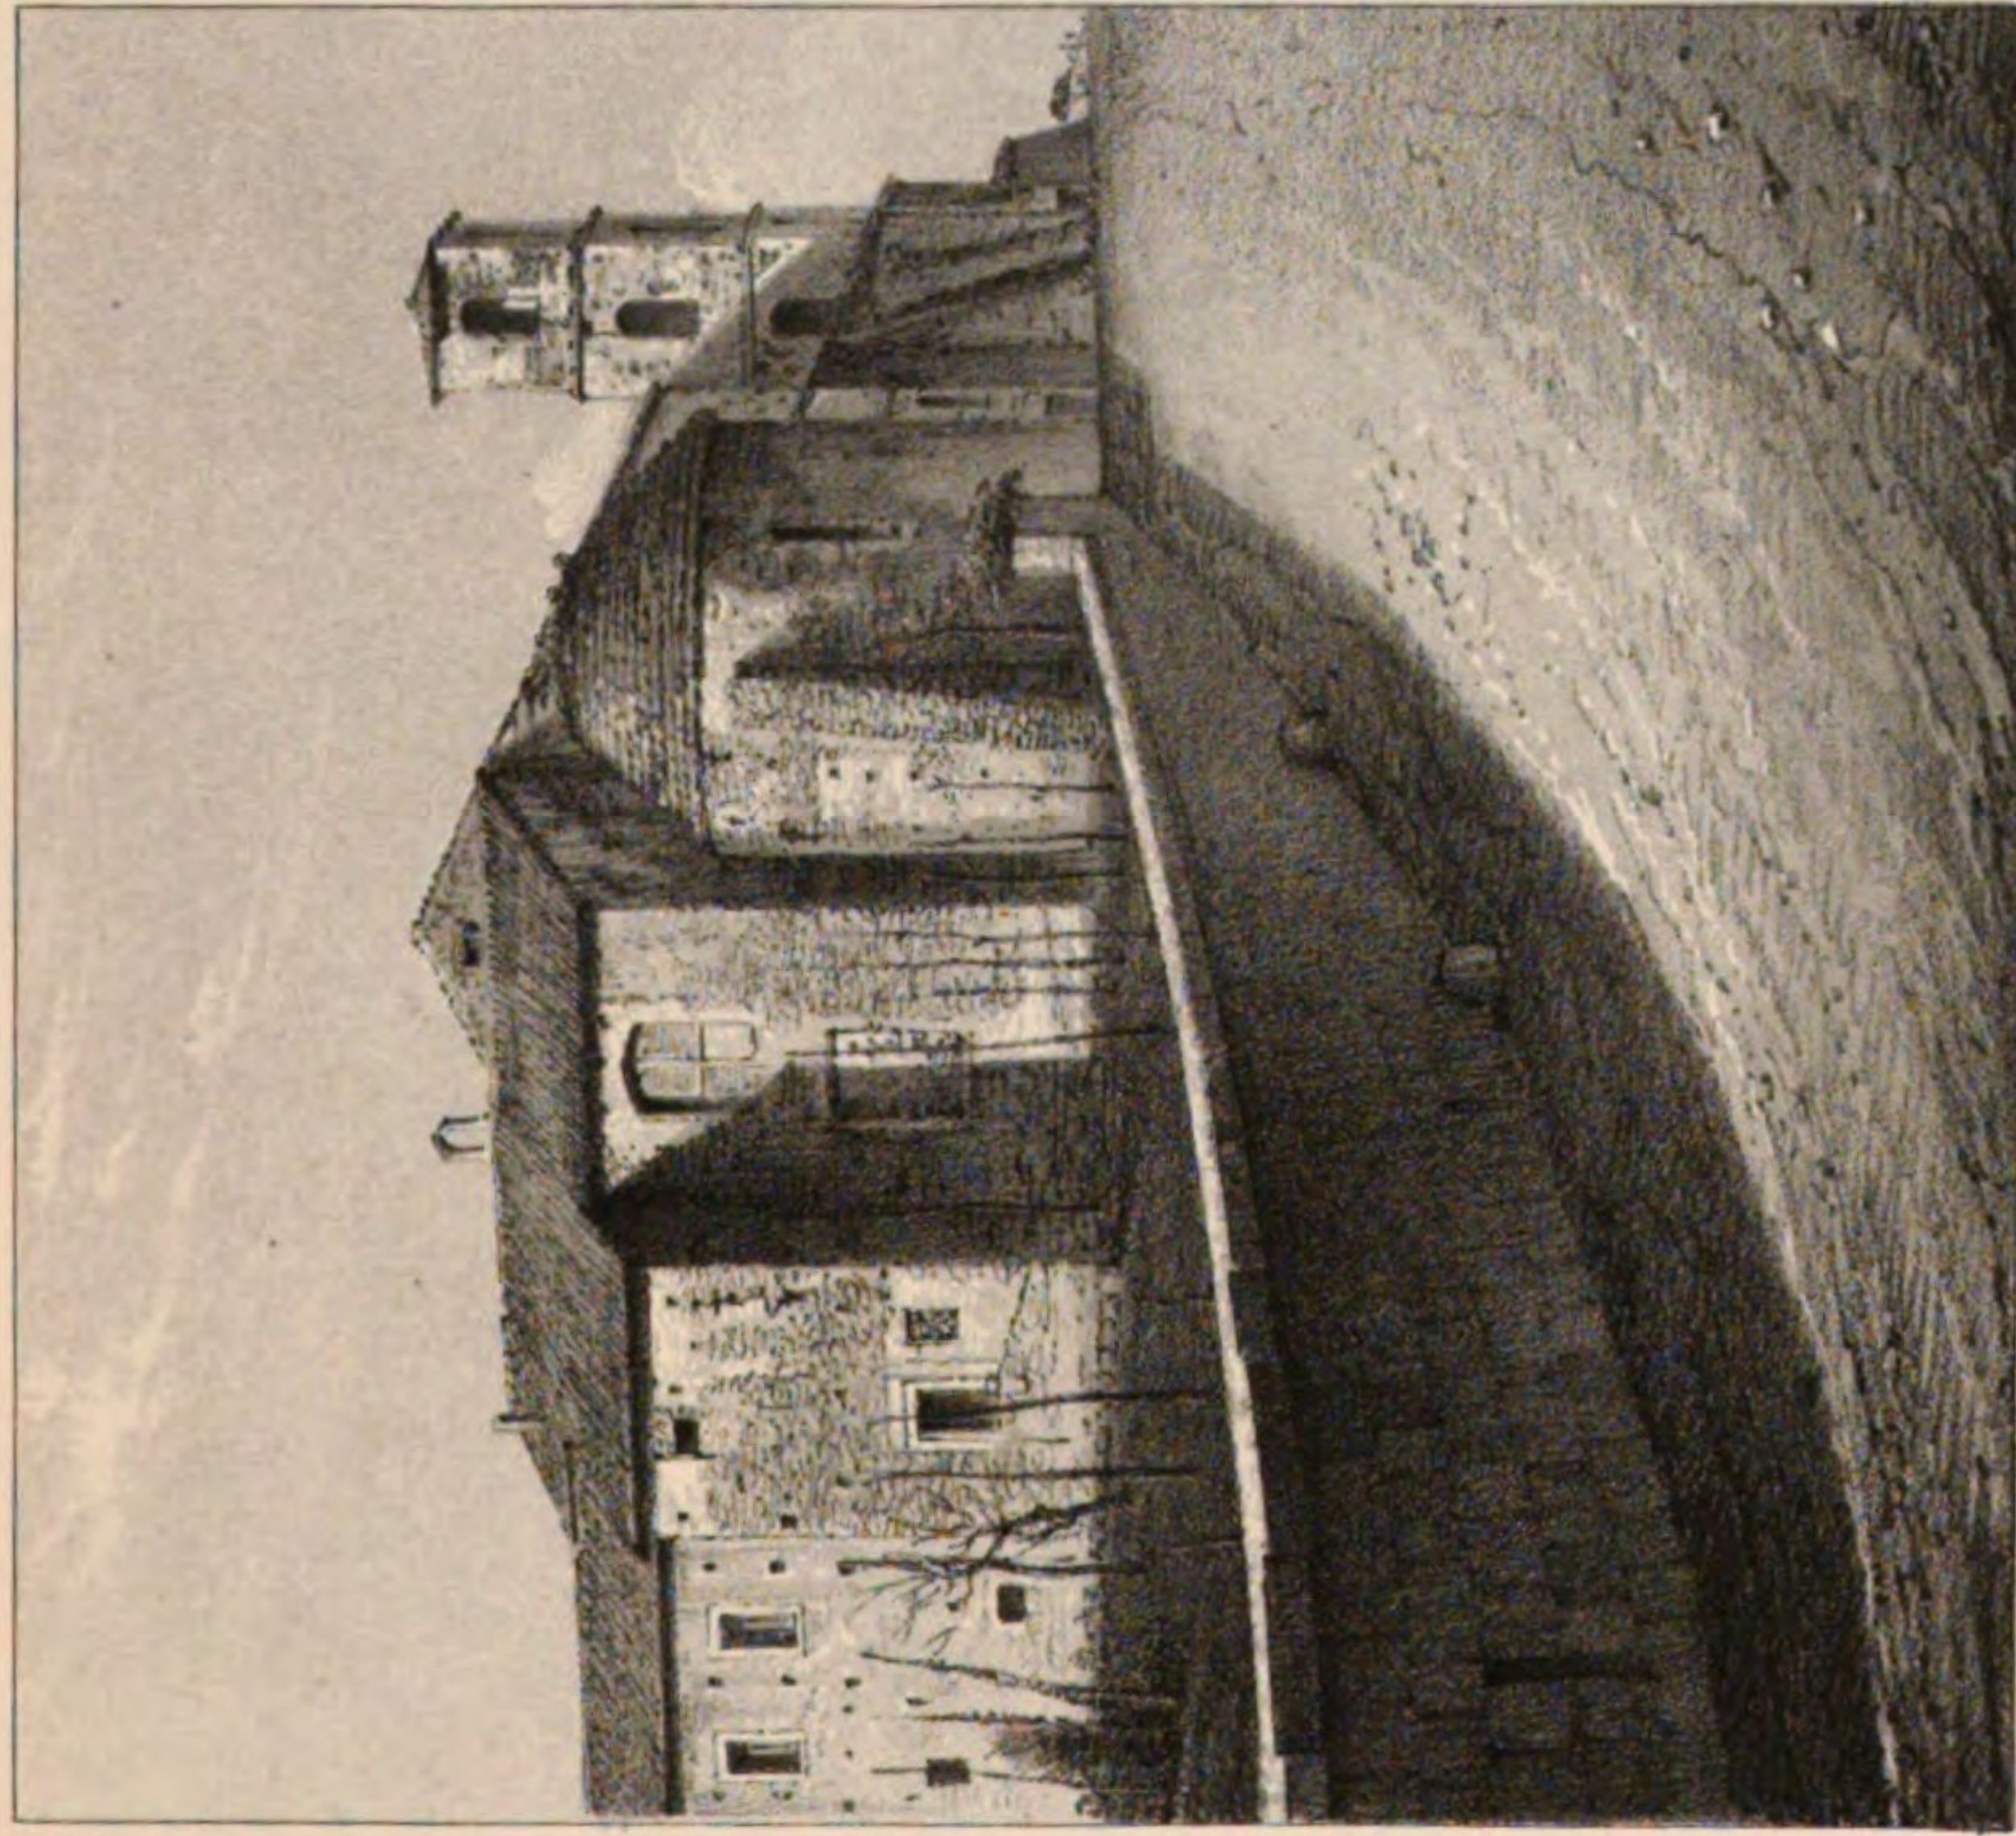
Photo. Pl. 125.

WEST FLANK. EBOLI.

None of the photographs (Figs. 124, 125, 126, Coll. Roy. Soc.), were taken sufficiently near, unfortunately, to show with distinctness any external fissures in this building, nor to show the S. W. angle at all. Referring to the block plan and elevation (Fig. 127), however, some large fissures in the external walls of the projecting buildings over the terrace, and, generally, in that portion of the structure, give an angle of slope with the vertical $= 15^\circ$ to 16° , and allowing for the change due to the ordinal of the building, indicate an angle of emergence for the wave-path $e = 18^\circ$ from the E.

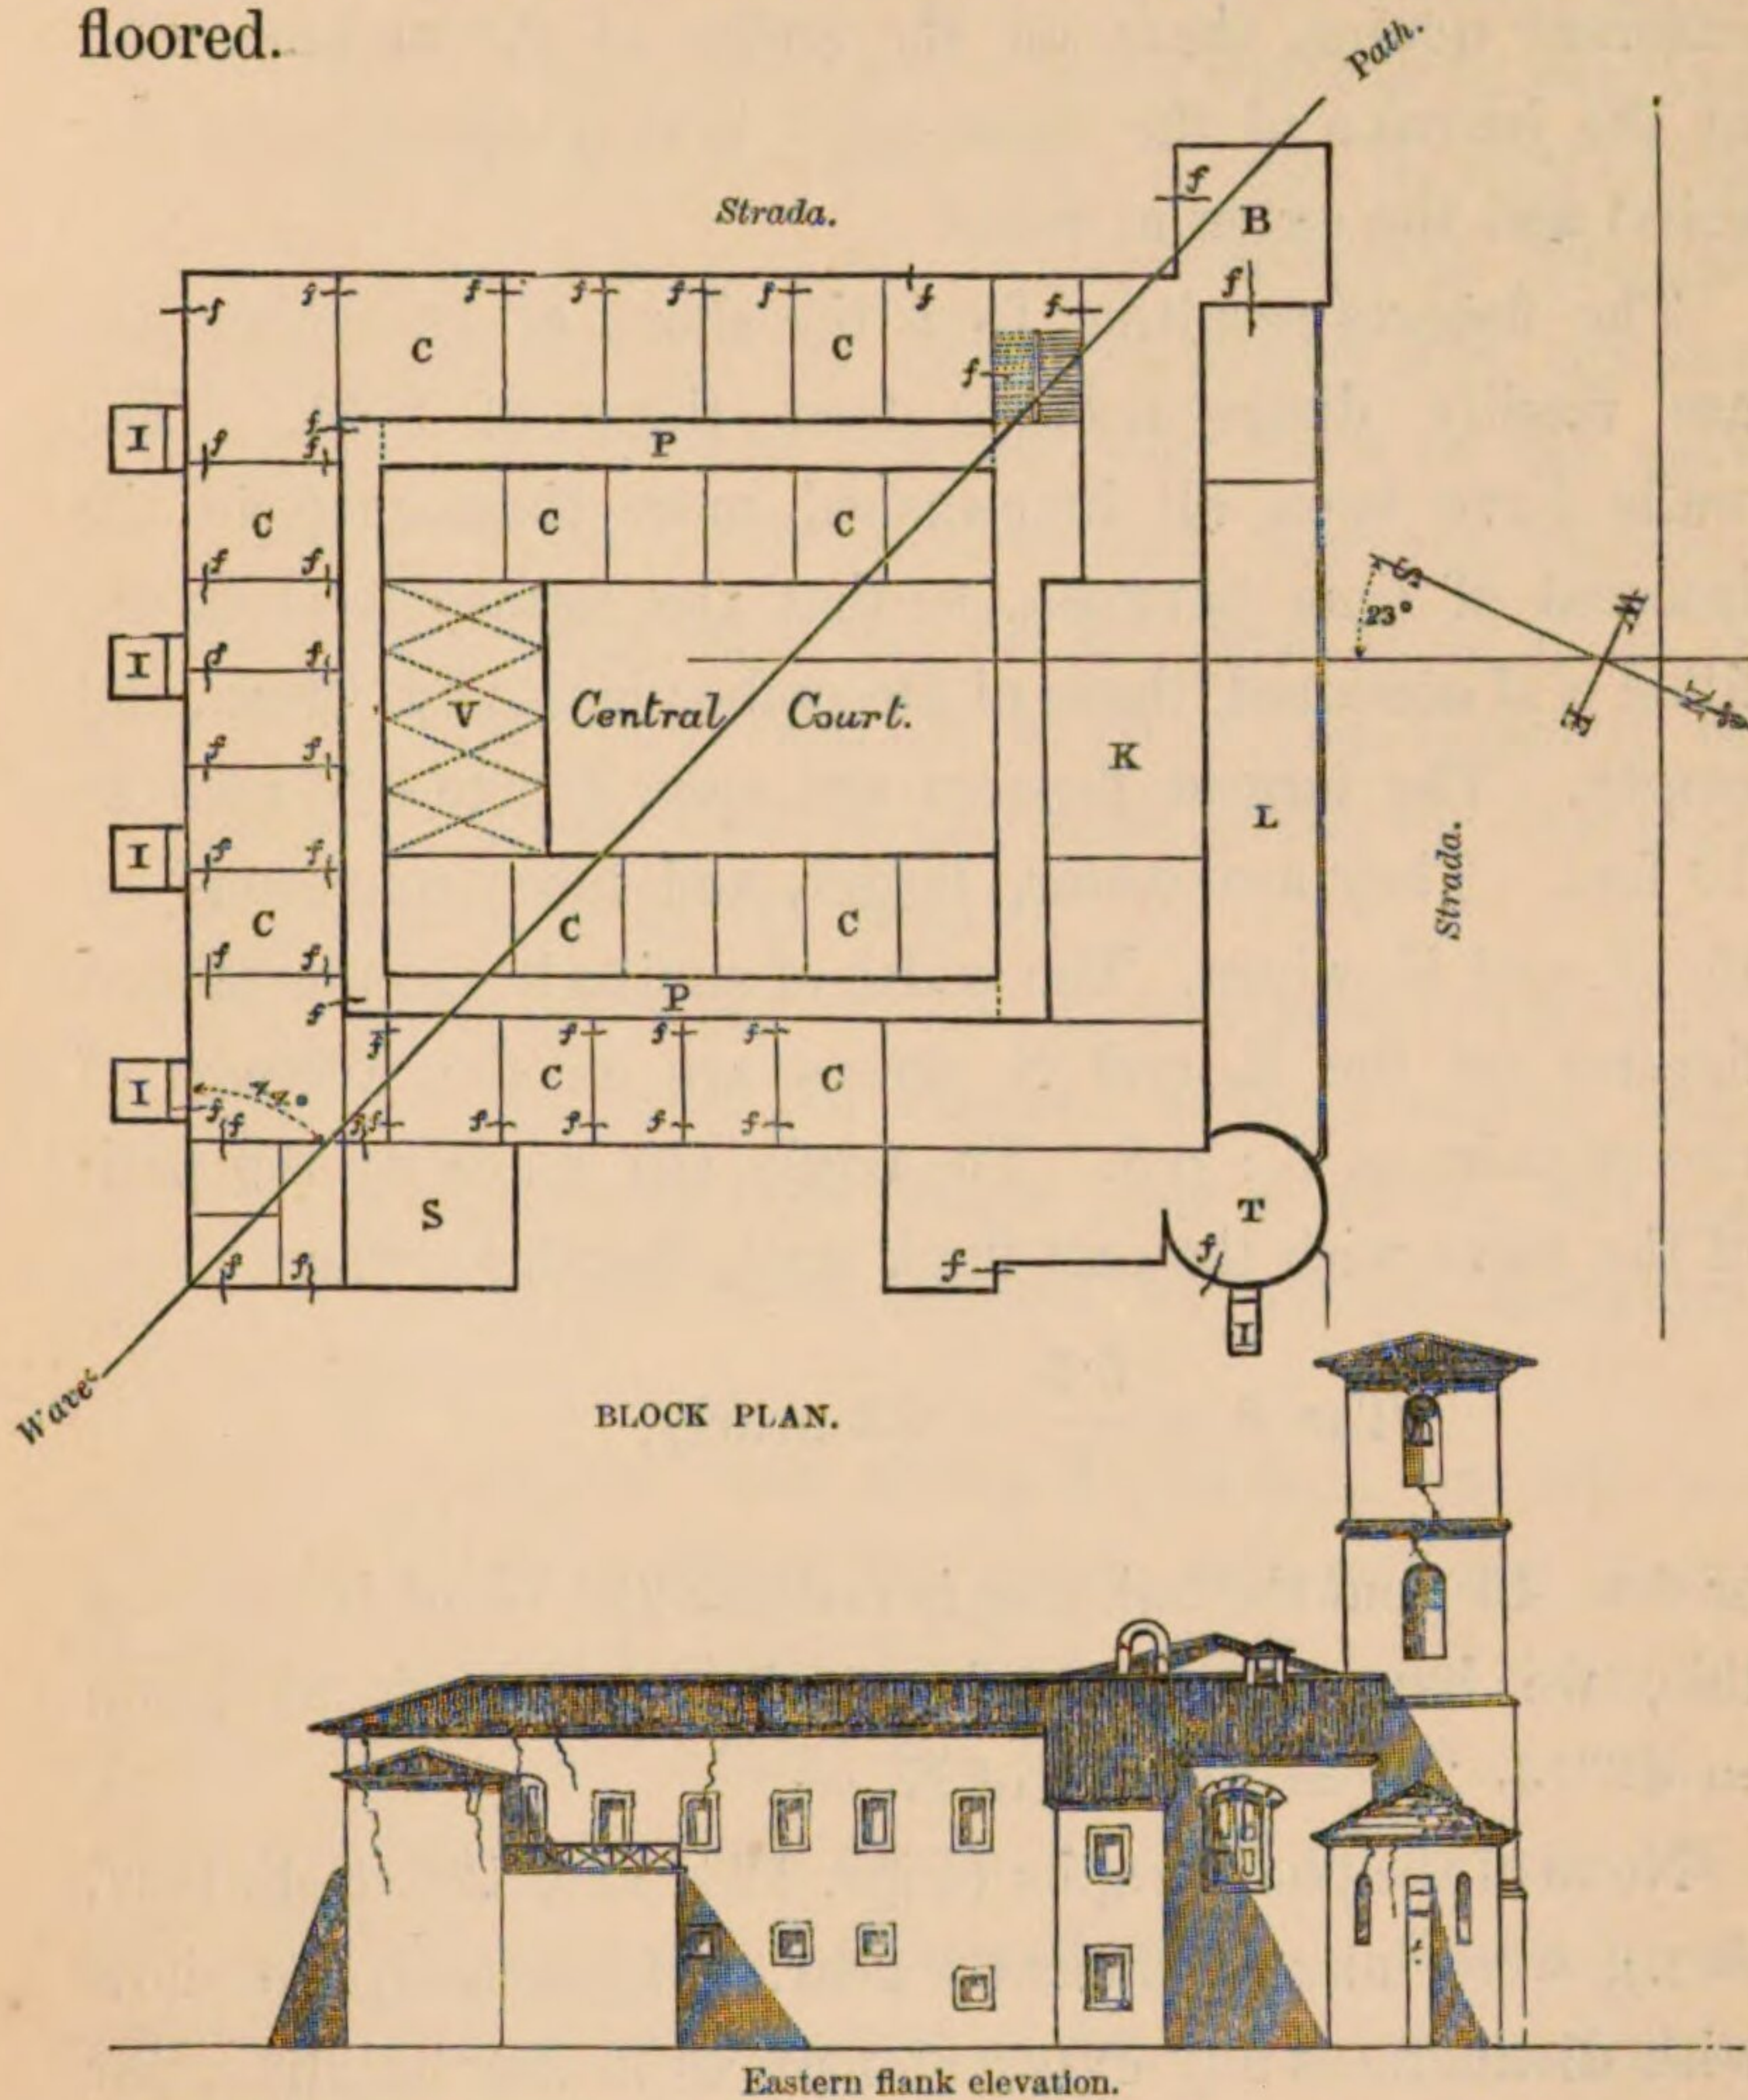
Fig. 127.

The whole building is fissured in almost every part, and yet not uninhabitable, all the fissures being narrow, and but moderately inclined, and its peculiar cancellated structure has, by the help of the mid lines of corridors, kept the roofing uninjured nearly.

The fissures that are most instructive, are those in the external quoins, those on the soffits of the arching, and at the junction of the cross walls between the rooms (or cells) and the external walls.

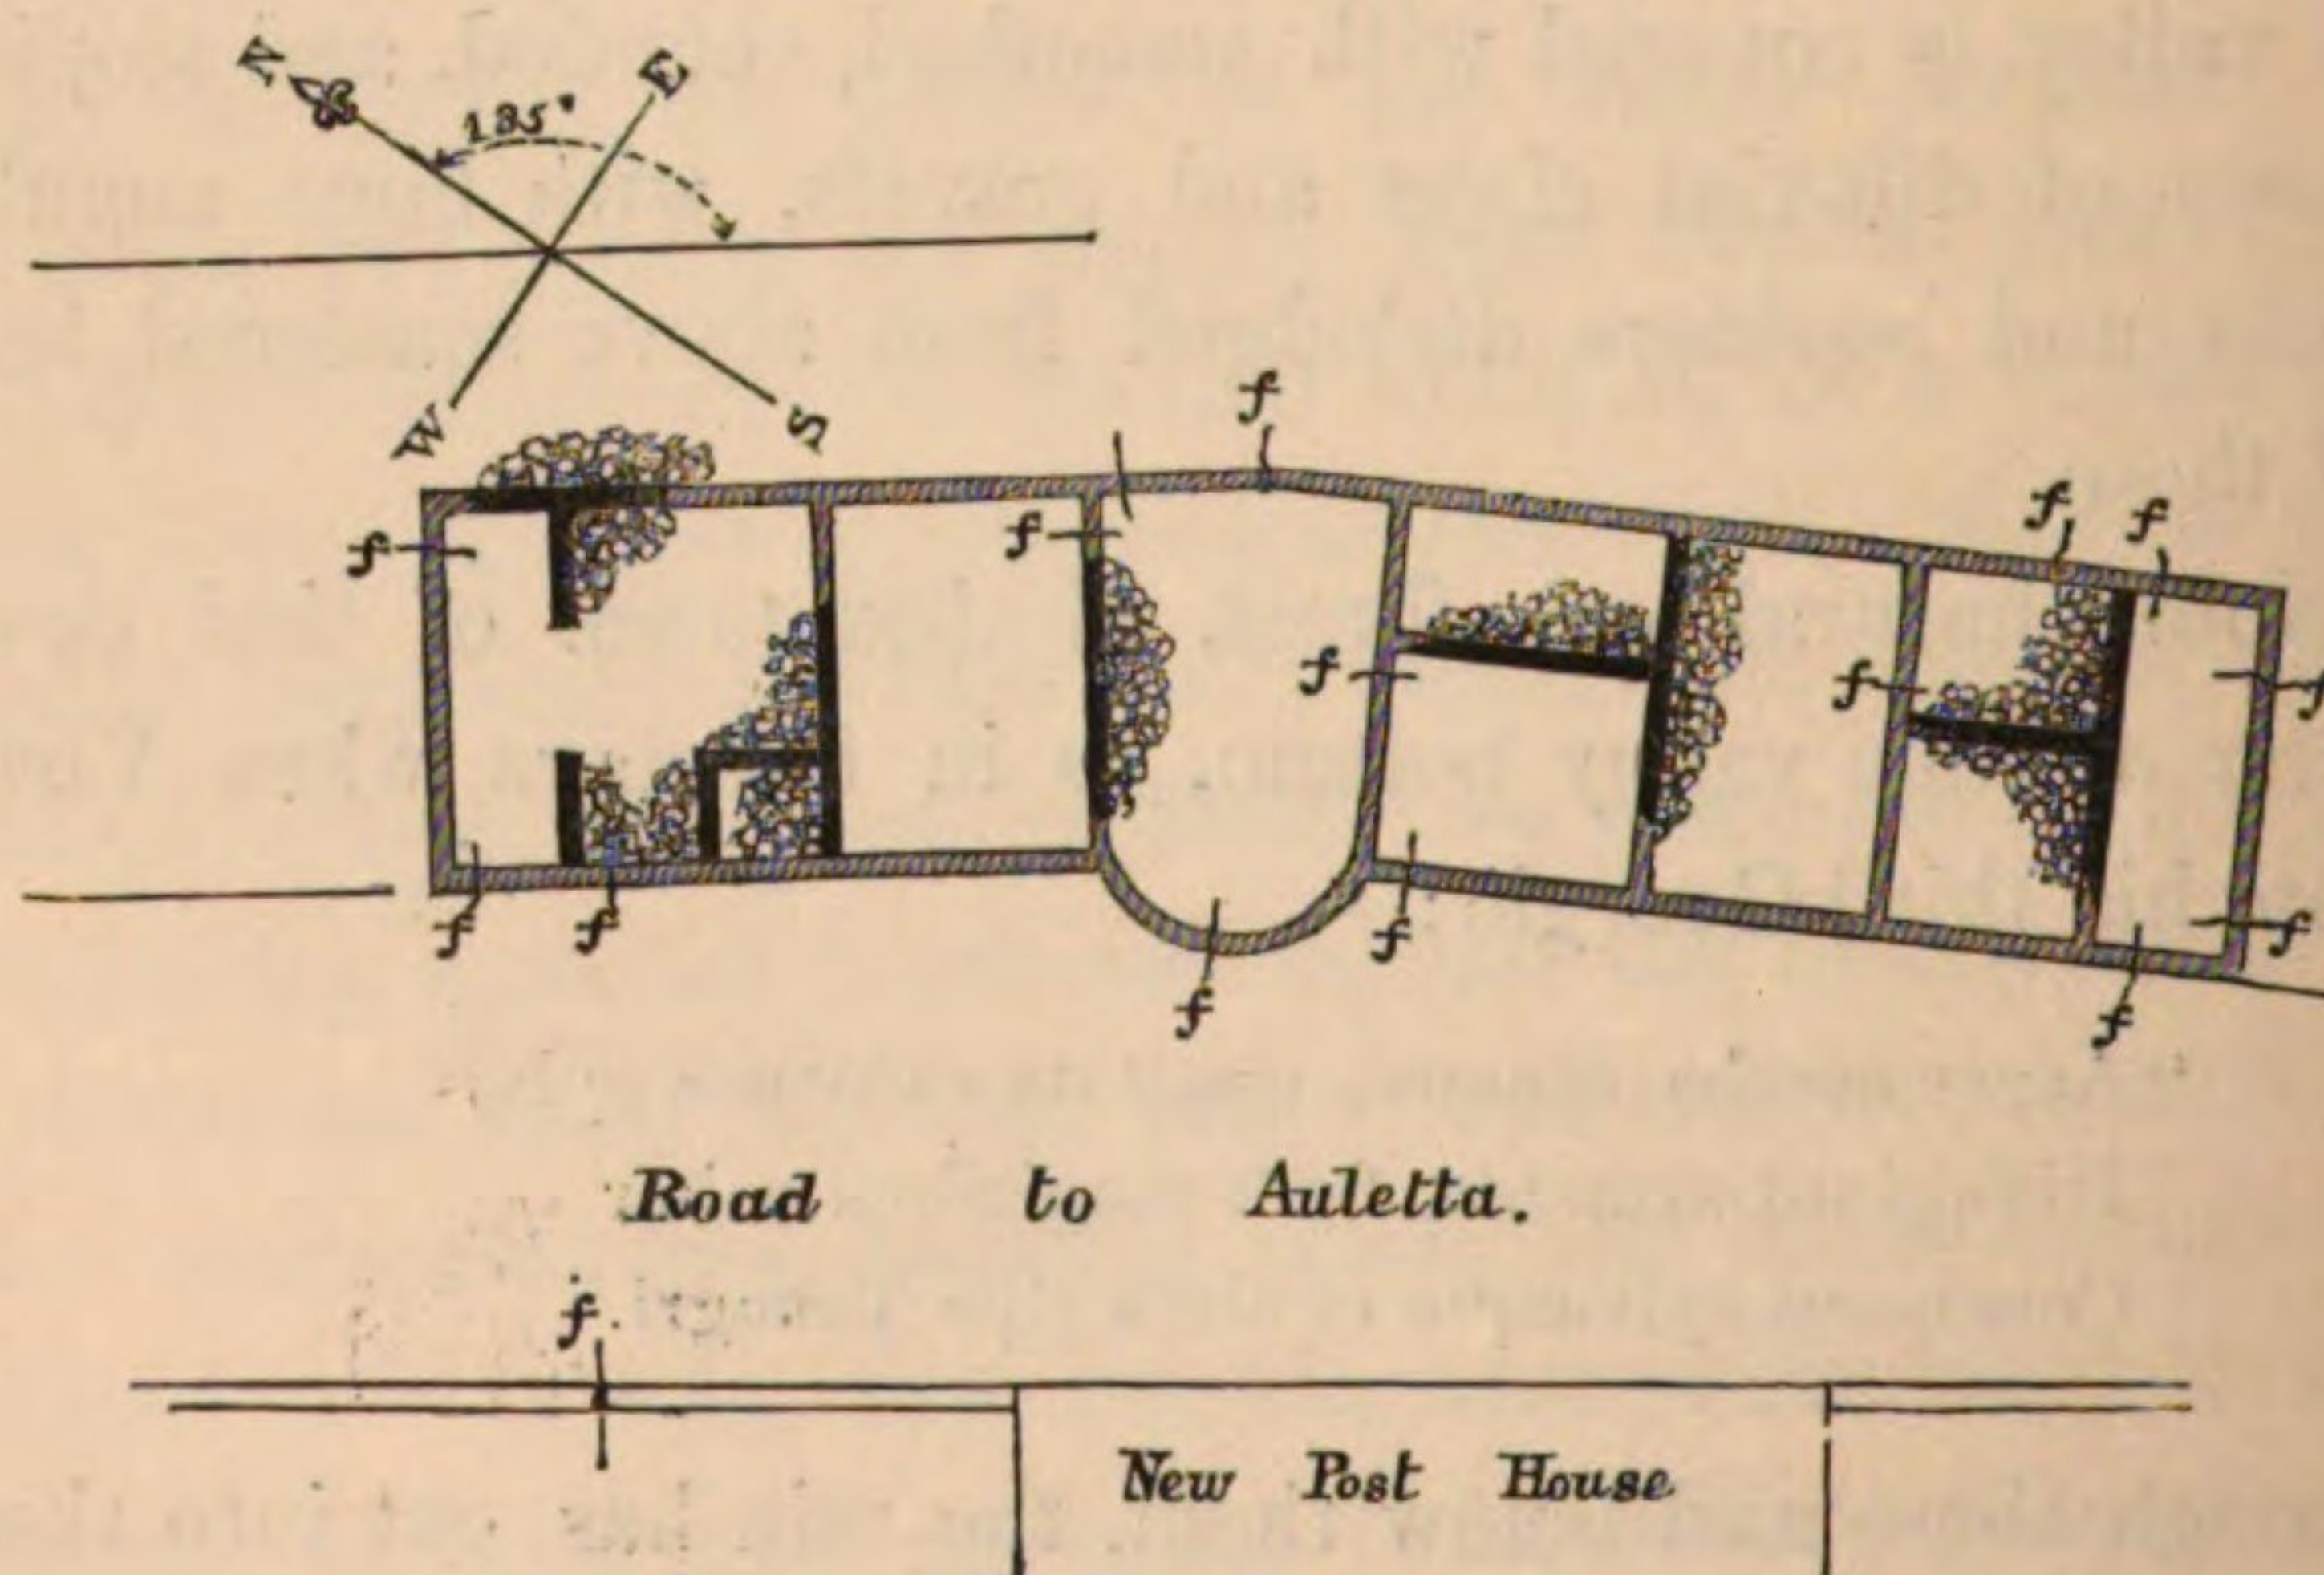
Fig. 128.

The place was damaged by the earthquake of 1783, and rendered uninhabitable by that of 1851. Its general length bears 135° E. of N. The fractures and fissures produced in December are clear and distinct from the old ones. In the sketch (Fig. 128), the portions coloured black indicate the

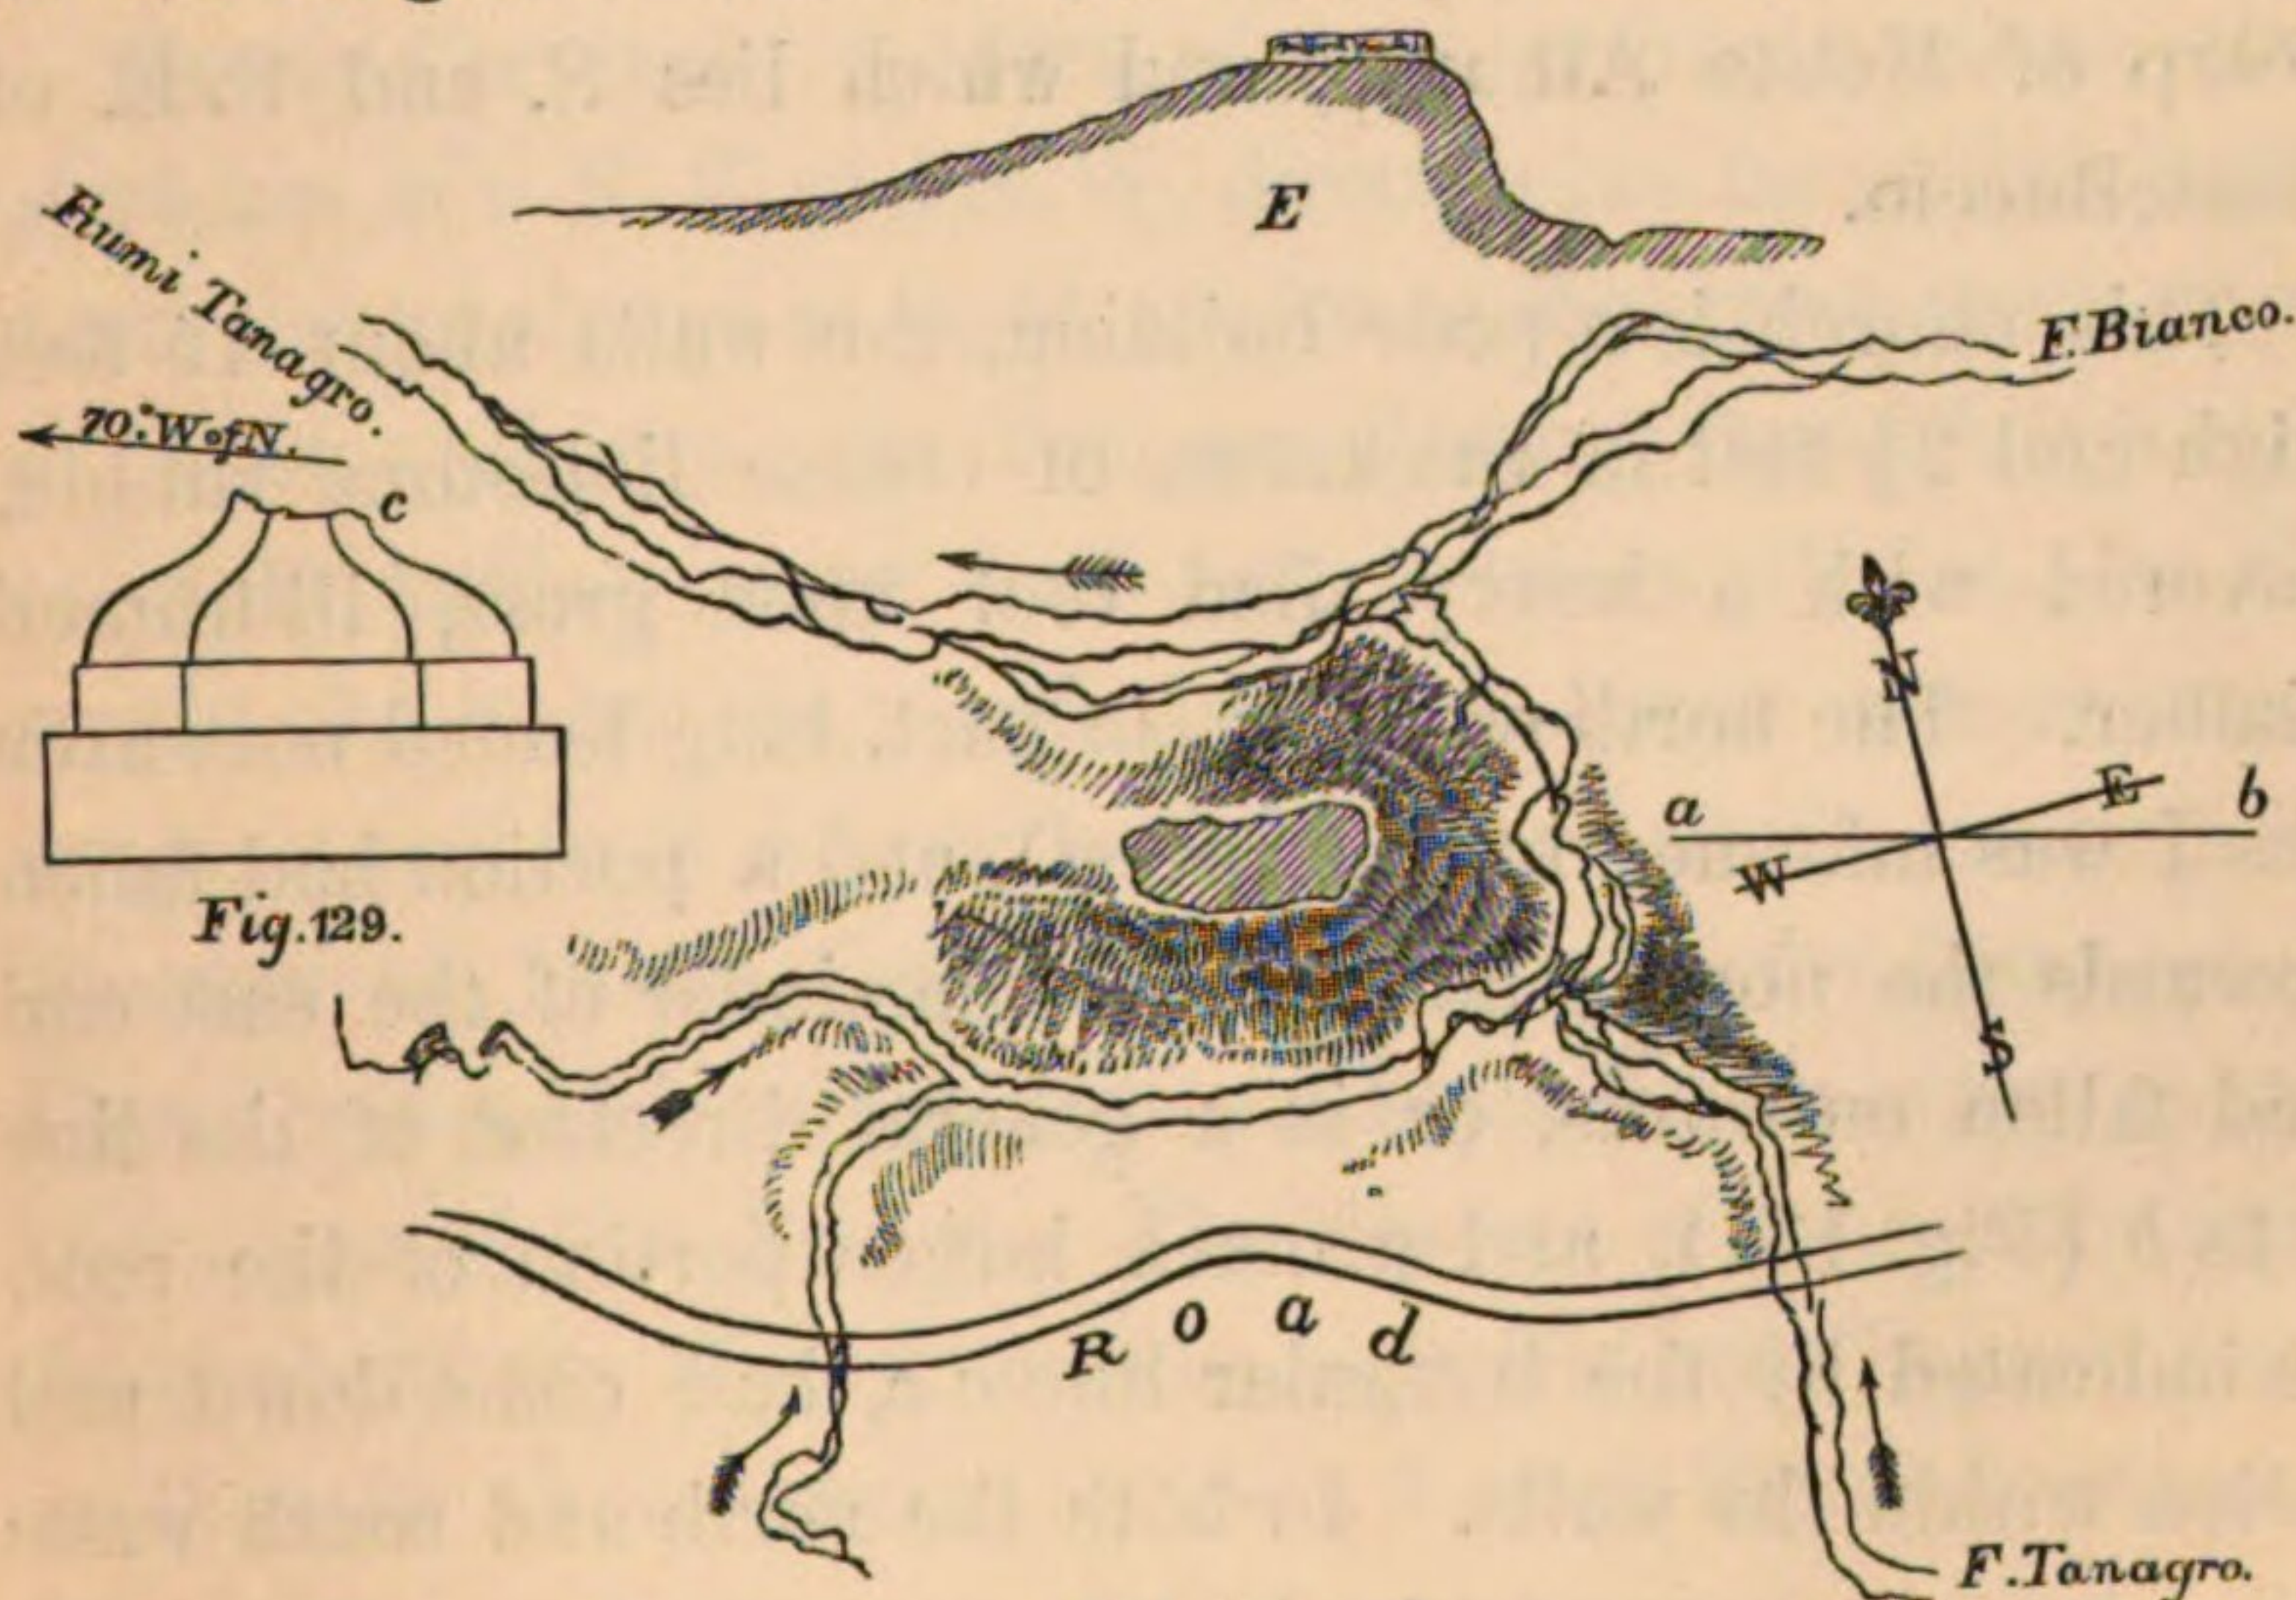
Fig. 130.

As I move round the base of the rock, I can see thus much reason for its comparative security, that the mass of solid limestone upon which it rests, presents its long way to the length of the valley, and lies nearly E. and W.,

with its steep end towards the east, and buttressed away to the westward by a longer slope, as in the section E (Fig. 130) taken in a line with *a b*.

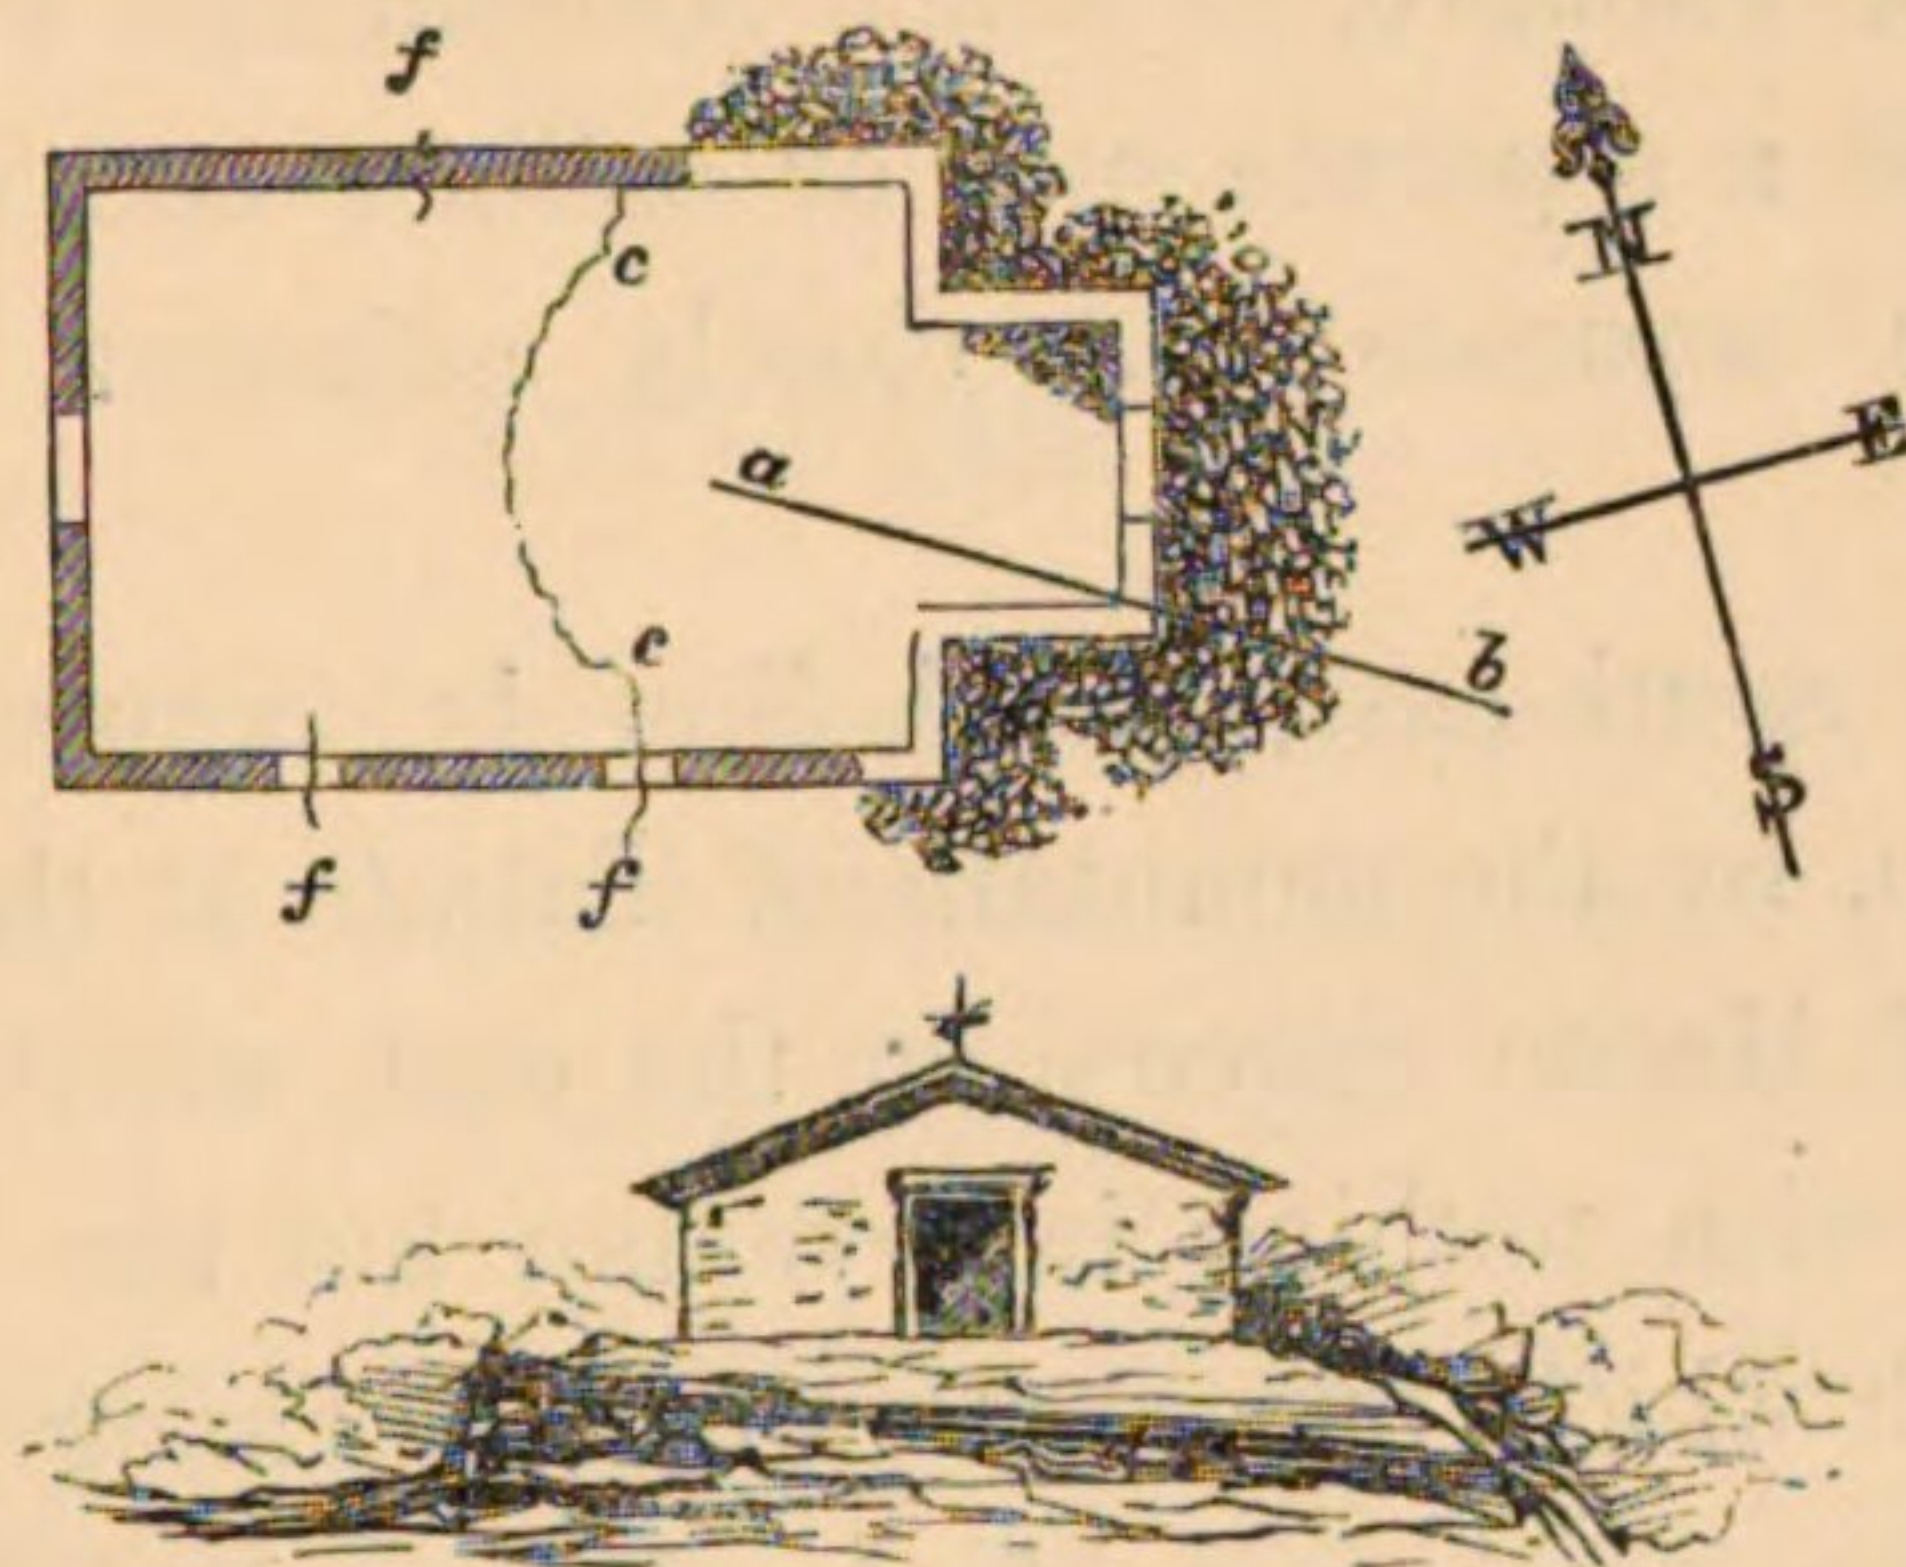
Fig. 131.

This church is a poor building, the walls about 15 feet high and $2\frac{1}{2}$ feet in thickness, of coarse limestone rubble, covered with a heavy tiled roof upon gross, ill-framed timber. The north wall had, in part, long leaned outwards (as I was informed by the priest), and a portion had fallen towards the north; but all the remainder of the east end had fallen outwards, or in a general direction of the line *a* to *b* (Fig. 131), and a much larger portion of the roof, as indicated by the irregular line *c c*, had come down and fallen within the walls. In both the north and south walls were some fissures *fff*, which, together with the general direction in which the mass of dislodged material had been thrown, indicated a wave-path of from $80^{\circ} 30'$ W. of N. to nearly due W. and E. The mode in which the roof

had come down, seemed to indicate a considerable amount of emergence in the wave-path, from the eastward, but

how much, neither it, nor the direction of the fissures, in the coarse rubble, and through the heads of the windows, would indicate.

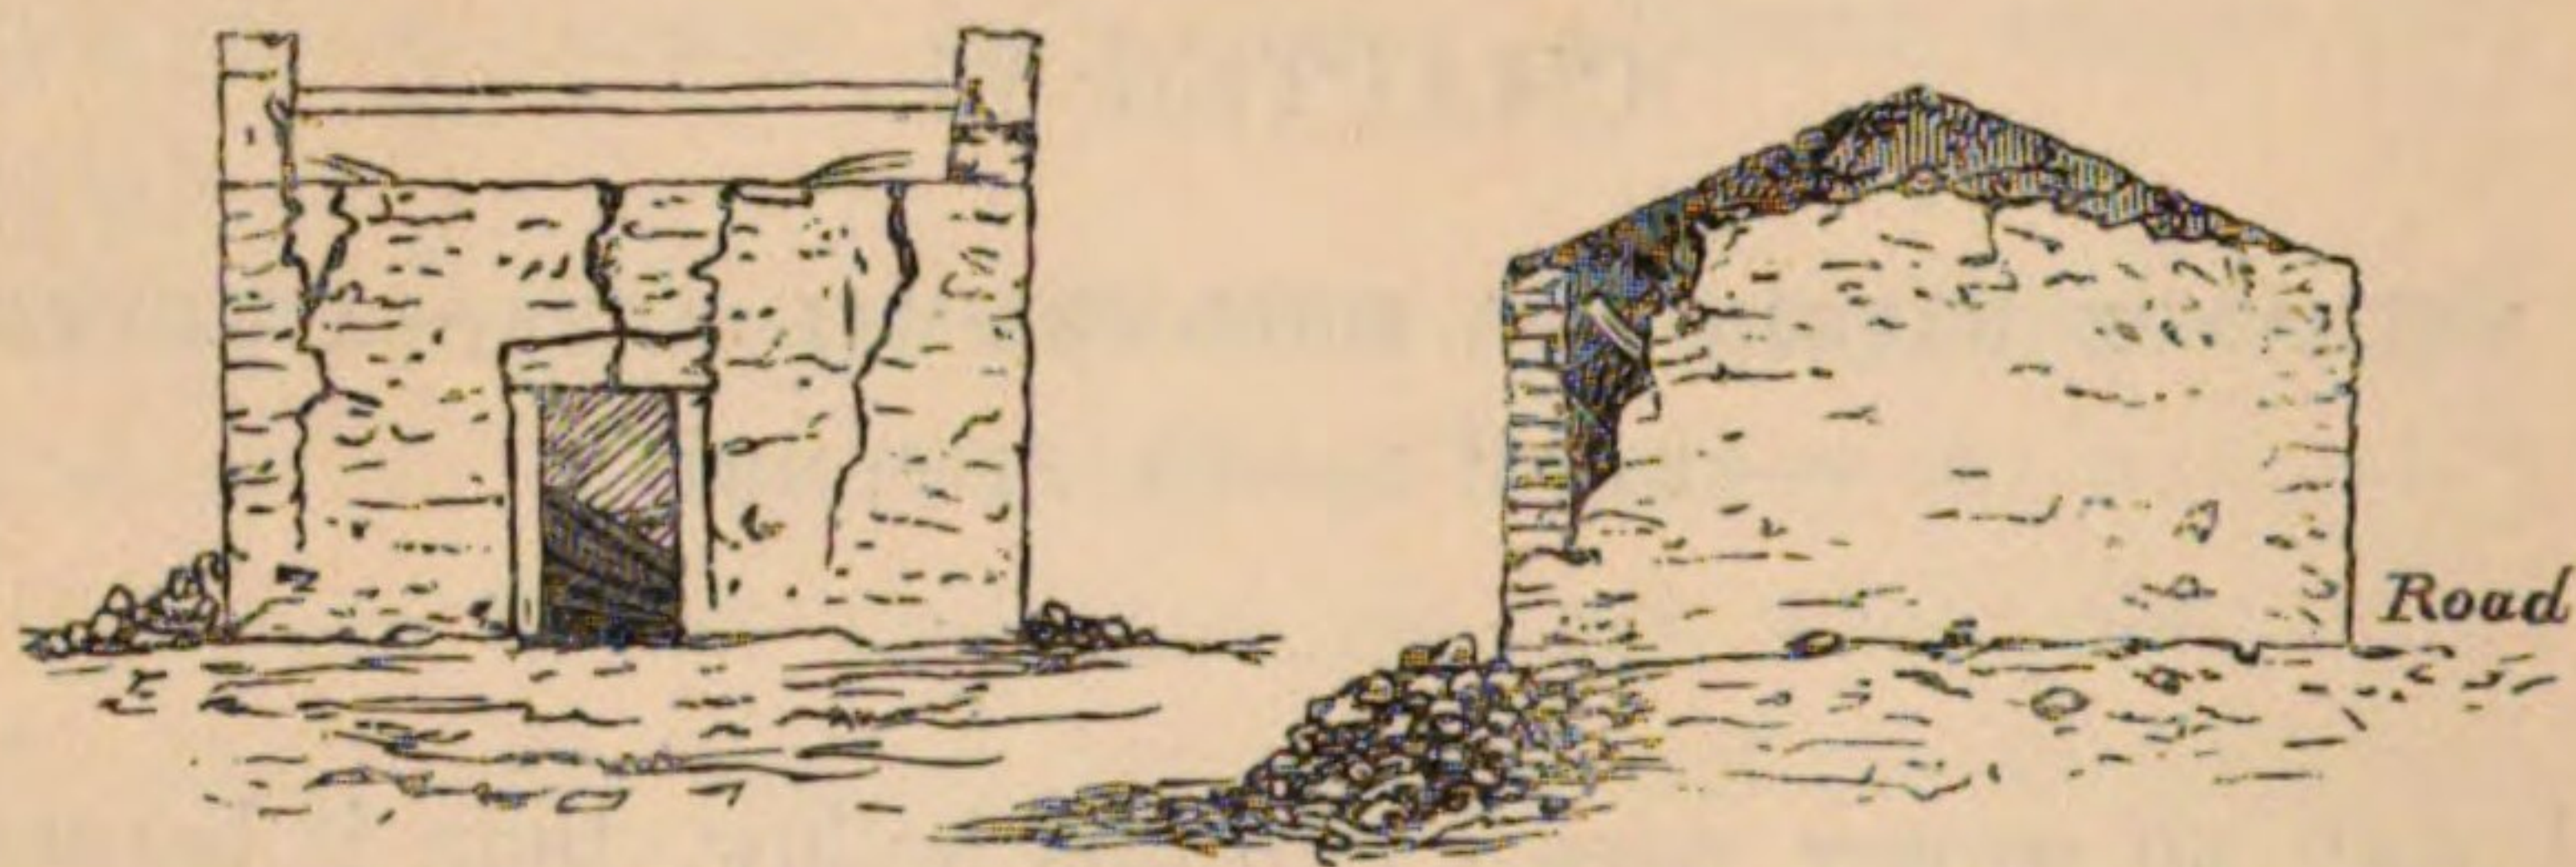
Fig. 132.

a great spread of gable, and front parallel to this little house, present evidences of great violence here, and extremely steep emergence of the wave. The house (Fig. 132) is fissured from wall plate and ground, in the north
